**From: Gretchen Knauff, Acting Director
Office of Services for Persons with Disabilities**

Re: New Haven Polling Place Accessibility Surveys

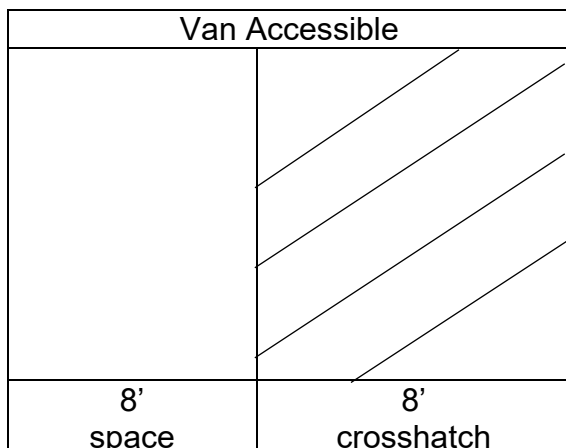
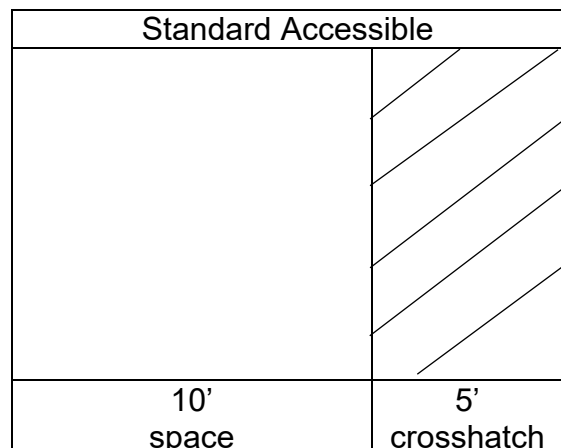
<u>Example of Signage Before January 1, 2017</u>	<u>Example of Signage After January 1, 2017</u>
  <p>A blue rectangular sign with rounded corners. At the top is the white International Symbol of Access (a person in a wheelchair). Below the symbol, the text reads "HANDICAPPED PARKING" in large white letters, followed by "PERMIT REQUIRED" in smaller white letters. At the bottom, it says "VIOLATORS WILL BE FINED MIN \$150".</p>	  <p>A blue rectangular sign with rounded corners. At the top is the white International Symbol of Access. Below the symbol, the text reads "RESERVED PARKING" in large white letters, followed by "PERMIT REQUIRED" in smaller white letters, and "VAN ACCESSIBLE" in larger white letters. At the bottom, it says "VIOLATORS WILL BE FINED MIN \$150".</p>
Standard Sign	Van Accessible Space Signage

Requirements	Signage Before January 1, 2017	Signage After January 2017
Background and Text Colors	Blue background with white lettering	Blue background with white lettering
Symbol of Accessibility	Static – International Symbol of Accessibility	Dynamic Symbol of Access
Required Language	“handicapped parking permit required” and “violators will be fined”	“reserved parking permit required” and “violators will be fined”
Must indicate the minimum fine for illegally parking in the space.	Yes For example: Minimum fine \$250.00	Yes For example: Minimum fine \$250.00
If the space is a van accessible space	Language on the sign must include: “van accessible”	Language on the sign must include: “van accessible”
